Afghanistan Clean Energy Program

Thawak Mission Report (May 9, 2010)

Field Evaluation of the THAWAK MICRO HYDRO (PANJSHIR)
Afghanistan Clean Energy Program (ACEP)
May 2010

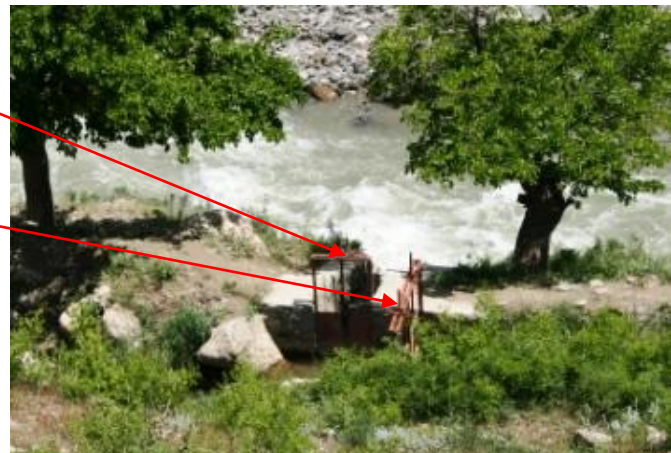
- Cement-lining of the canal at the beginning of the headrace (about 200m), which was prone to damage/clogging with debris during times of high flow. The cement lining should reduce the period maintenance/cost on the canal and increase the reliability of water supply.
- The capacity of the whole length of canal (including the initial cement lined part and the remaining earth canal) appears to have been increased. This should allow for more water to be carried, resulting in less concern by farmers regarding irrigation requirements for their land located downstream of the MHP intake.
- Construction of a spillway and installation of sluice gates to control flow into MHP forebay.

Spillway gate

Main gate to control
flow to forebay and
d/s irrigation

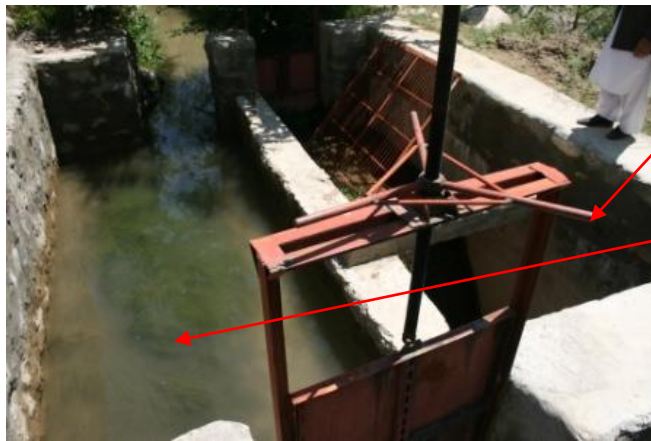
- Construction of a by-pass at the forebay for irrigation water, and installation of sluice gates to control flow into forebay and or irrigation by-pass. One of the sluice gates requires minor maintenance (installing nut/bolt).

Fore bay

By-pass for irrigation

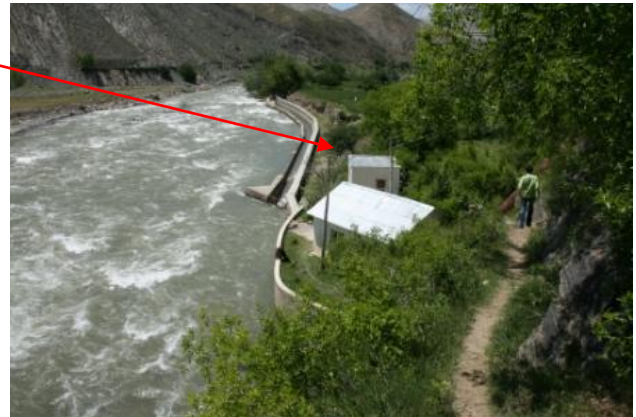
New operator house

- An operator's room right next to the powerhouse. This should provide for better monitoring of the power plant by operators once the plant is put back into operation. However, the glass window glass panes are all missing and some damage has been inflicted to the main door. These need to be repaired or replaced.

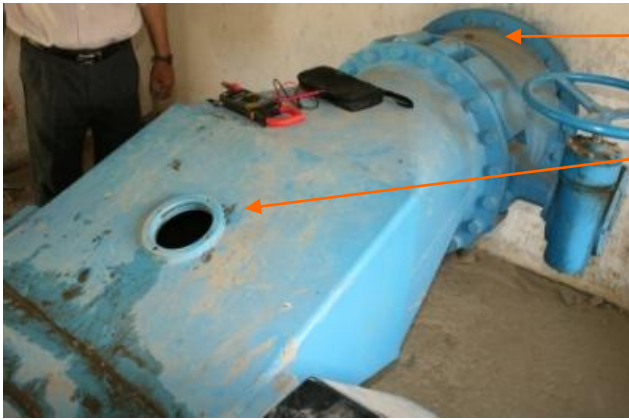
- As per the suppliers' information sheet, the turbine is a cross-flow type made of Inox steel. The set includes a butterfly type inlet valve with a manual hand wheel used to operate the valve through a gear-mechanism. The turbine as a whole and the valve set appear to be in good condition with the exception of the inspection cover, which needs to be replaced. Some damage has been caused to two of the runner blades; it appears that they were stuck by a boulder from the tailrace pit. As the damage appears minor (bending of two blades at a certain location probably accounts for negligible area compared to the whole area through which water would flow) and IREM (the principle supplier) has not suggested any action, it is suggested to leave the blades in the present condition. Should there be any noticeable effect of this on the plant's performance (unusual noise or reduction in power), a corrective measure should then be taken. It was not possible to rotate the turbine shaft by hand. After looking through the inspection cover, it was revealed that a large piece of cloth has been stuck to the side of the turbine rotor. This needs to be removed as part of the rehabilitation work.

Missing pressure gauge
Missing Inspection cover

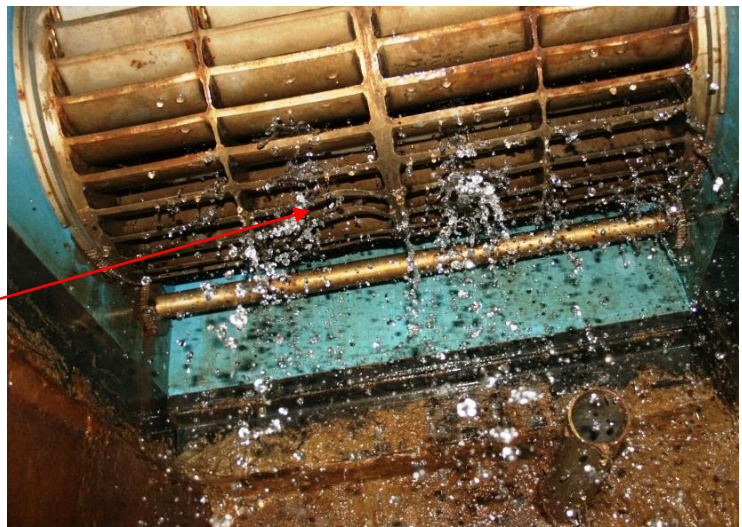
Damaged runner blades

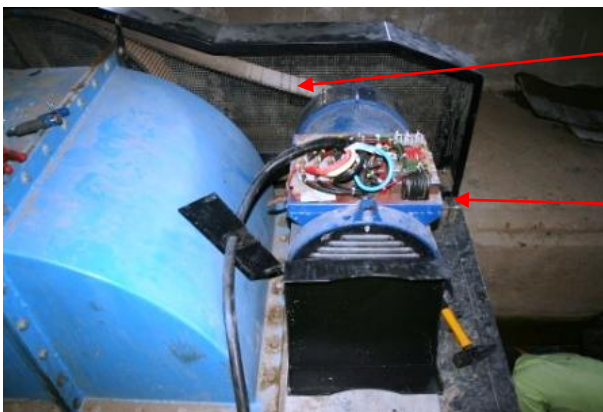
- The generator is a 4 pole, 1,500 rpm 230/400 V synchronous generator with brushless type and compound excitation. Physical inspection showed the generator to be in good condition. It was not possible to rotate the generator without completely removing the belt as the turbine on the other end of the belt was jammed with debris/cloth.

Cogged belt drive

Generator inspected after removing top cover

- The 1,500 rpm generator is coupled to the slow rpm turbine through a cogged-belt drive system. Physical inspection showed the belt to be worn out and possibly not suitable for transferring 50kW of power. As a result, the belt needs to be replaced. Reportedly, one set of belts is in stock and is being

held by locals). A new set should be procured to maintain the stock. Since the belt set was kept in tight condition for long without rotating, there is a possibility that the bearing of the generator may need to be replaced. The cogged pulleys on the turbine and generator shafts appeared to be in good condition.

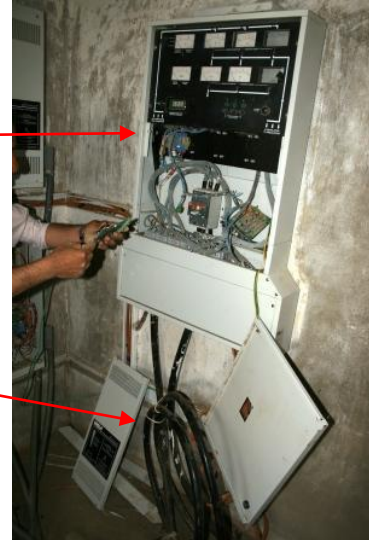
- The main power cable connecting the generator to the main control panel also appeared to be in good condition.

Damaged main control and instrumentation panel. Circuit breaker seems to be OK.

Power cable from the generator to the control panel seems to be OK.

- The main control panel's instruments and wiring was found damaged. The power circuit breaker appeared to be in good condition. Nevertheless, it is suggested that a new control panel set be purchased and that any usable components in the old one, such as the circuit breaker be kept as spares for future use.
- The main power cable connection between the control panel and distribution board was found to be cut and will need to be replaced.

14	Supply/install main control, switchgear and instrumentation panel	1 set	From IREM	Good components from existing one, including circuit breaker, may be kept as spares
15	Supply/install underground power cable main control panel to distribution board	1 lot		
16	Supply/install flexible power and grounding cable from main control panel to electronic load regulators in cable trays	1 lot		
17	Supply/install underground power cable from distribution board to first pole (Thawak line)	1 lot		
18	Supply/install power cable from distribution board to first pole (Anoba line)	1 lot		
19	Supply/install grounding copper wires/cable from generator to control panel to distribution board to nearest PH grounding rod outside	1 lot		
20	Disassembling turbine, cleaning turbine rotor and penstock end of mud, pebbles, cloths; replacing / re-greasing bearings	1 lot		A large piece of cloth seems to have become entangled at the side of the rotor and is jamming it. The rotor cannot be moved by hand

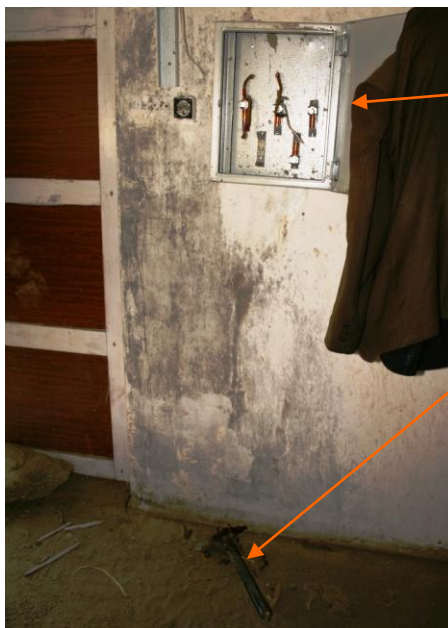
Damaged distribution board

Cut power cable

- The distribution board (DB) with a set miniature circuit breaker (MCB) was destroyed and will need to be replaced. The DB individually controls the power supply to Thawak and Anoba villages.
- There are six sets of load regulating boxes, two for each phase. These keep the speed and voltage of the turbine-generator constant by regulating power to and from ballast heaters in the tailrace

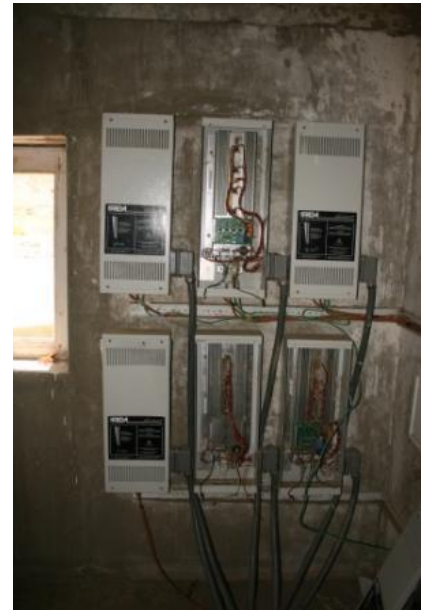
based on the demand in the village. Whereas the top three regulators were found to be in good shape, the bottom two were destroyed and the third in bottom row had a slight indent on the front cover. It is suggested to buy three sets as replacement and keep one as a spare if not used (plus there is already one in stock).

Top three load controllers appear to be OK (we removed the middle cover for inspection)

Bottom two located on the right are clearly damaged

12	Provide/install complete set of ballast heaters and connecting cables	6 sets	From IREM	1 in stock, any useful from those damaged can remain in stock
13	Supply/install electronic load regulators	3 sets	From IREM	2 regulators are badly damaged, 1 may be damaged, 3 appear OK, 1 in stock

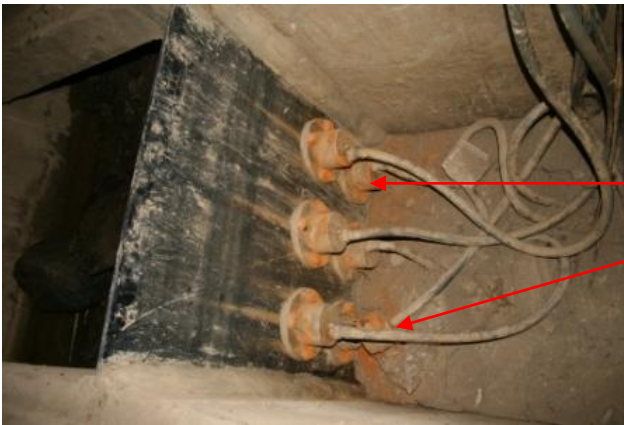
- The six ballast heaters installed in the tailrace are each connected to one of the load regulators. There are clear signs of damage on two of them while the rest may be usable. These heaters are relatively inexpensive; it is suggested to buy a whole new set. There is also one spare set with the villagers.

Some heater connection box and cables are damaged. Heaters protruding into the tailrace are mostly bent and later straightened.

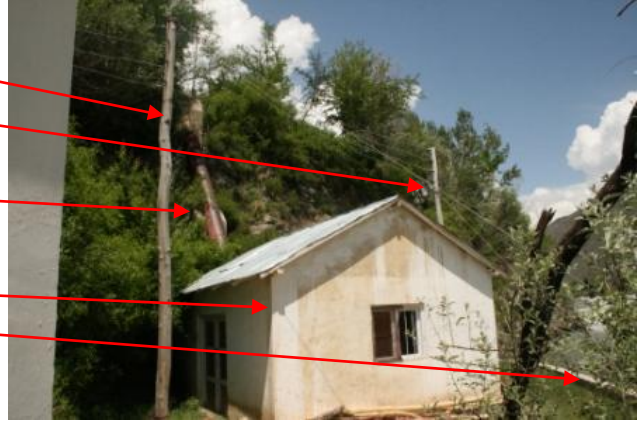
- The main power cables connecting the DB to the first pole to Thawak and the first pole to Anoba have both been stolen. These need to be supplied and installed. The penstock pipe looks fine but needs to be repainted with a coat of anti-corrosion paint.

First pole to Anoba village
 First pole to Thawak village
 Penstock pipe
 Panjsir river
 Flood retaining concrete wall

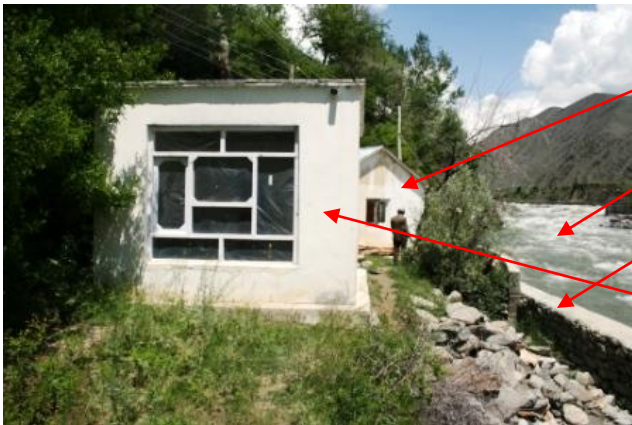
- The powerhouse building itself looks OK except for the damaged window panes. It is suggested that all the glass panes be replaced with new ones, and a metal door and windows be installed to deter forceful entrance into the powerhouse by unauthorized persons.

Powerhouse building
 Panjsir River
 Flood retaining wall
 Operator's house

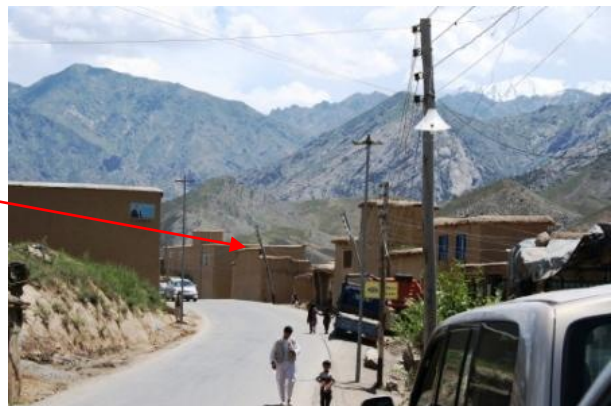
- The distribution line poles from powerhouse to Anoba and power house to Thawak largely appear to be in good condition. However, there are some poles that are tilting beyond acceptable angle and need to be straightened and secured. It was also reported by SESA engineers (was not possible to walk the whole length of distribution line at the time of the visit) that the distribution wires have been cut at an unspecified number of locations. These need to be repaired and the poles brought back into an upright position. Some of the wooden poles will need to be replaced with steel/reinforced concrete poles along the distribution lines. These should be surveyed, quantified and installed.

Tilting pole in the Anoba bazar

21	Installing stay/guy wires or supports to distribution line poles that are at bends and not adequately positioned	?		Some poles along the Anoba line could be seen tilted; total quantity needs to be assessed
22	Reconnecting any broken wires along the LT distribution lines	?		Quantity of work needs to be assessed
23	Cleaning, installing, testing, and putting into service	1 lot		
C	Others			
24	Meetings with community and local administration to prepare for handover	lot		
25	Training operators			
26	Taxes, duties, etc.	%		Importable items to be supplied through IRG, while payment through SESA
